## Investigation on the Causes of Failure and Repair of Manual Water Pump

Abdulrahman, K. O. and Luqmon, A. S.

(Department of Mechanical Engineering, University of  
Ilorin, Ilorin, Nigeria)

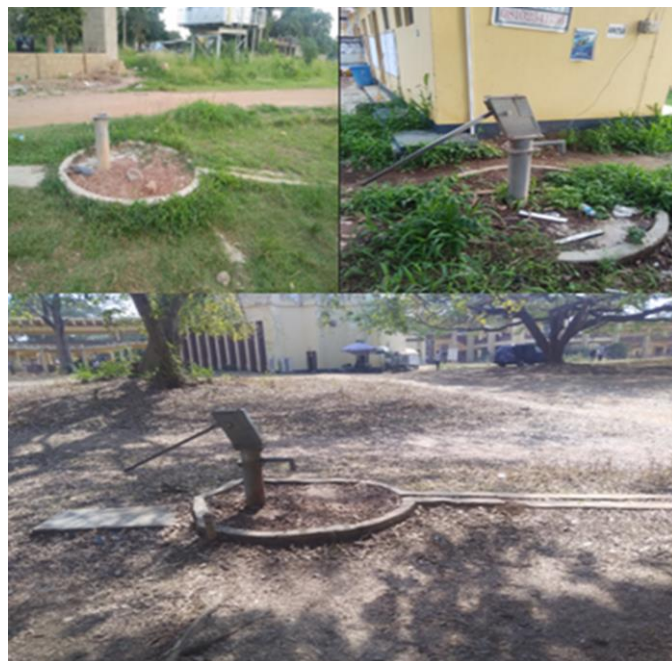
However, manual pumps are prone to failure and often require maintenance [8-9], often leading to frustration among communities and abandonment of the pumps as shown in Figure 1. Understanding the causes of failure and effective remediation are crucial to ensuring the sustained functionality of these essential devices. This study delved into the intricacies of manual water pump systems, investigating the

**Figure 1: Typical Images of Abandoned Manual Water Pumps**

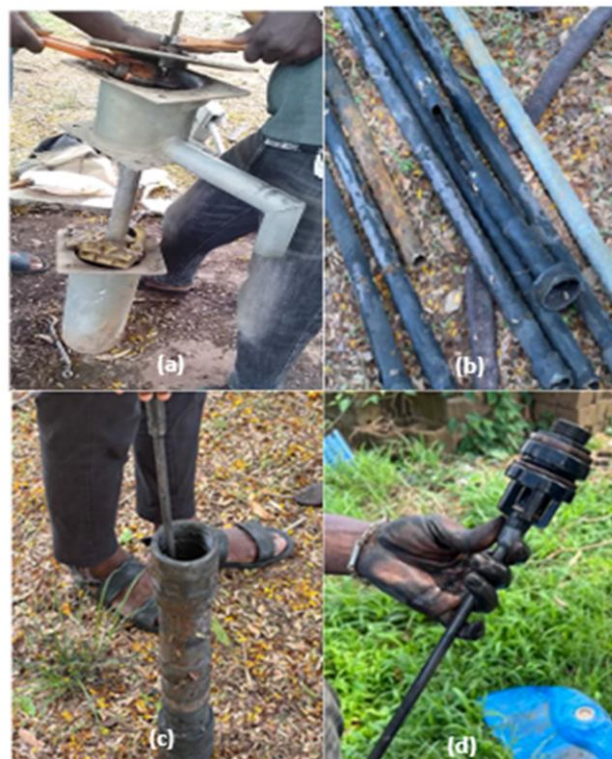
On-site inspections were conducted to evaluate the physical condition of the manual water pump before and during the dismantling process. Observations focused on symptoms of pipe damages due to wear, corrosion and breakage that could indicate potential failure points. Figure 2 shows some components of the hand pump.

**Figure 2: Components of Dismantled Hand Pump (a) Discharge Pipe, (b) Suction Pipes with Sockets, (c) Pump Cylinder, and (d) Connecting Rod with Socket**

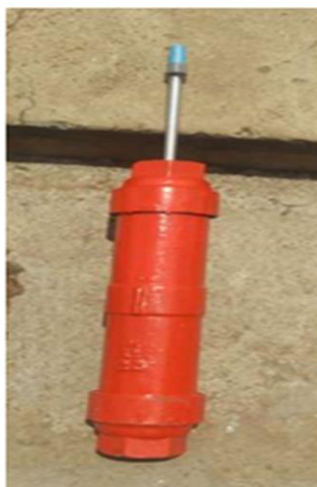
**Figure 3: Installed Upgraded Cylinder**

Upgraded cylinder component (Figure 3) and highly durable galvanized pipes (Figure 4) were installed to reduce the likelihood of future corrosion. Teflon tape was applied to all threaded connections to enhance sealing and prevent leakage under varying operational pressures. Reassembly was conducted in a step-by-step manner, ensuring all seals, washers, and joints were properly placed. Thereafter, the repaired system underwent comprehensive testing, including a functional test to verify smooth operation and water discharge (as shown in Figure 5). Leakage test to check for leaks at connection points during operation, and a load test to assess performance under varying usage conditions, ensuring the effectiveness of the repairs and improvements were carried out.

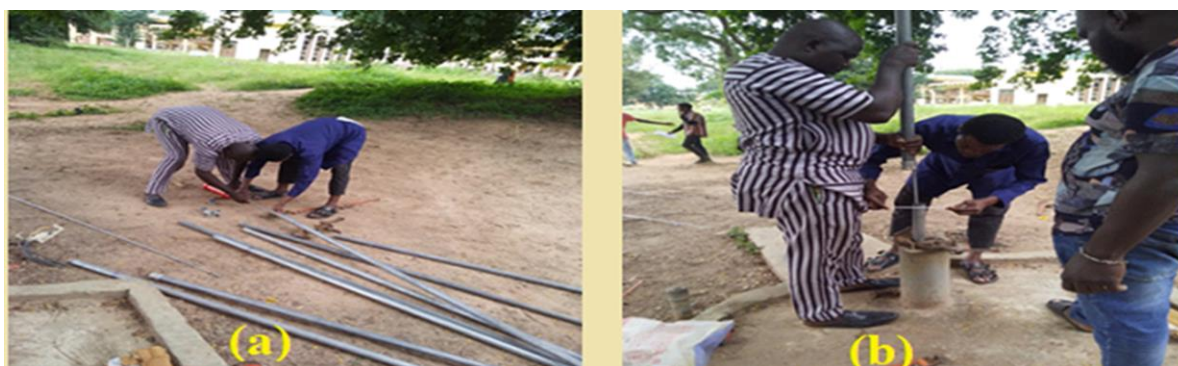
**Figure 4: Repair and Assembling of (a) New High-durability Galvanized Pipes (b) Cylinder Insertion into Borehole**

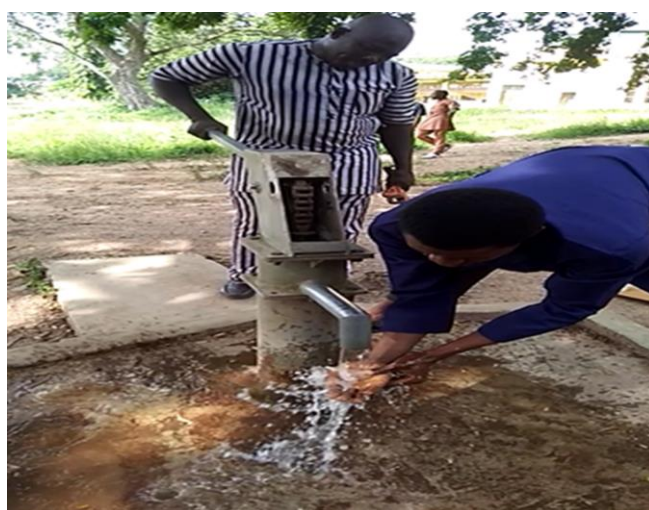
**Figure 5: Testing of the Repaired Hand Pump**

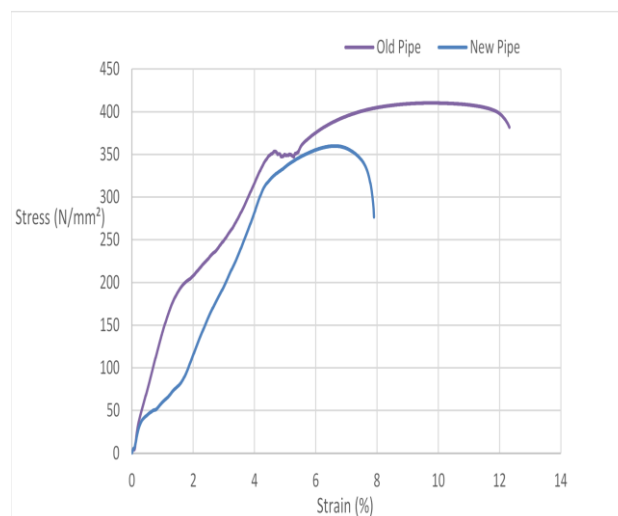
The average UTS for old pipe samples is 371.22N/mm<sup>2</sup>, while that of the new pipe samples is 392.57N/mm<sup>2</sup>.

Also, average Yield Strength (YS) obtained for the old pipe samples is 321.900N/mm<sup>2</sup>, while the average YS for the new pipe is 392.434N/mm<sup>2</sup>. Notably, the average UTS and YS values of the newly installed pipe samples exceeded those of the old pipe samples from the failed pump. The values suggest that the new pipes exhibit superior material quality and increase durability. The selection of these pipes for repair will ensure enhance safety and longer

**Figure 6: Stress/Strain Curve of Old and New Pipe**

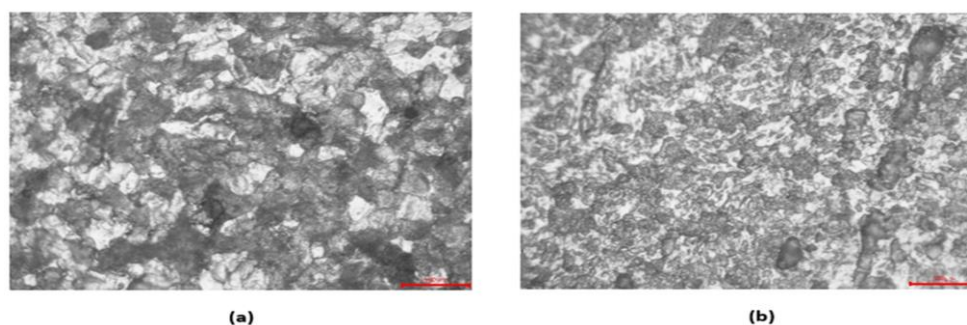
The micrographs of sample of old and new galvanized pipes are presented in Figure 7. Under identical magnification (50X), it becomes evident that the old galvanized pipes exhibit larger grain sizes compared to the new ones.

This distinction is of considerable importance as it implies a higher susceptibility to corrosion for the old, galvanized pipes, given that larger grain sizes can facilitate the penetration of corrosive agents and weaken the material's structural integrity [10].

Figure 7: Micrographs of (a) Old and (b) New Galvanized Pipes

For manual water pump installations, it is therefore recommended that corrosion-resistant alternatives like PVC and stainless-steel pipes should be considered to extend the system's lifespan. Thorough water analyses should be Conducted before installation to understand elemental composition, especially iron levels, aiding material choice and corrosion prevention. Regular maintenance schedules for inspections and early issue detection should be implemented. Suitable coatings or inhibitors should be applied for corrosion protection, especially on galvanized pipes. Stringent quality control in manufacturing should be advocated to meet corrosion resistance standards and reduce maintenance needs. Pump cylinder conditions should also be assessed so as to replace worn or corroded parts promptly.
